GW-1000 Main MCU Firmware update

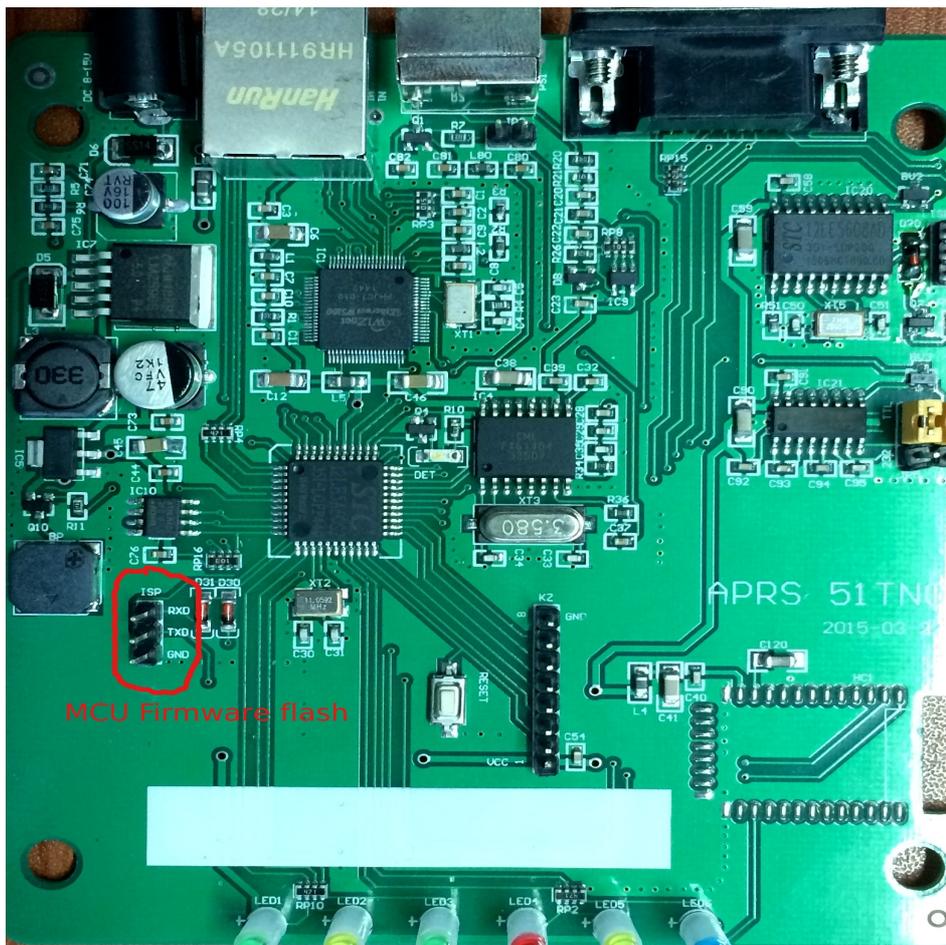
The location of the pin socket for flash the MCU. Foot mark is ISP.

1. Install the driver if you use USB serial to TTL cable.
2. Plug the serial to TTL cable to the computer.
3. Install STC MCU flash program. Run it.
4. Connect the serial to TTL cable to the ISP pin socket on the GW1000 PCB.
5. Choose MCU type. It is STC12LE5A60S2. It is in the STC12C5A60S2 series
6. Click the Open-Code-File, choose the latest firmware .hex file.
7. Choose the COM port of the cable.
8. Click 'Download Program' button.
9. Connect power to the GW-1000.
10. Reset the GW-1000.
